Acer Travelmate 220 Disc Drive Replacement

Replacement of optical drive.

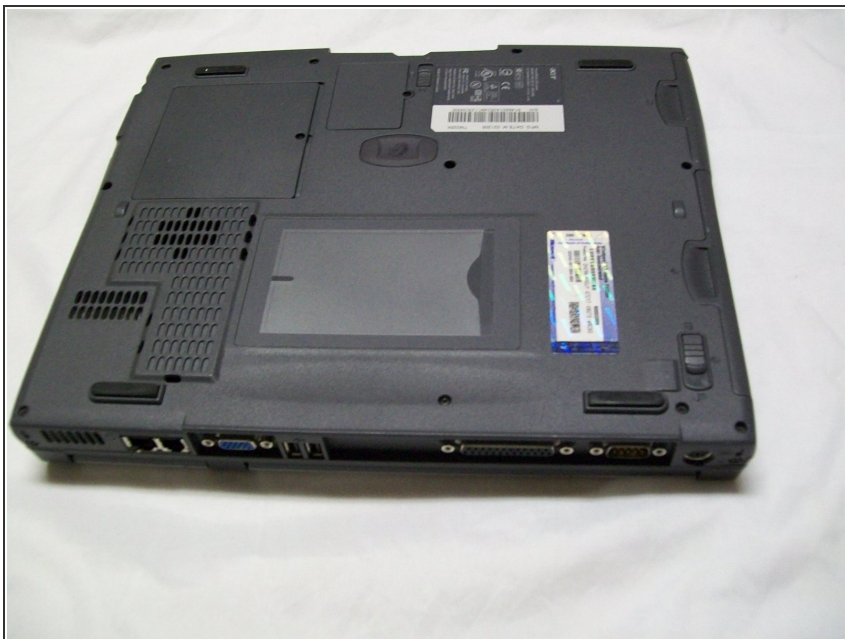
Step 1 — Disc Drive

- Flip your computer over so the bottom case is facing you.

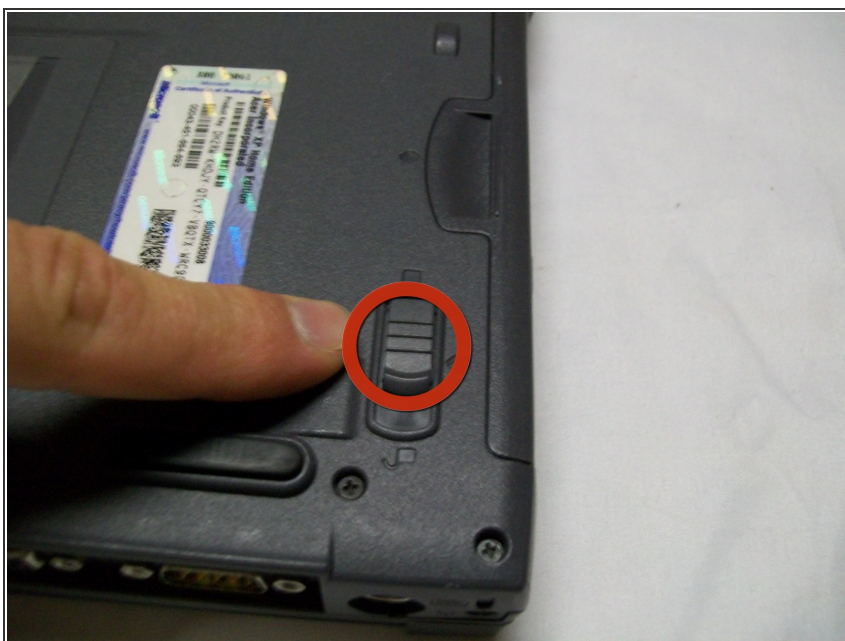
Step 2

- Locate sliding unlock button near the AC power input.

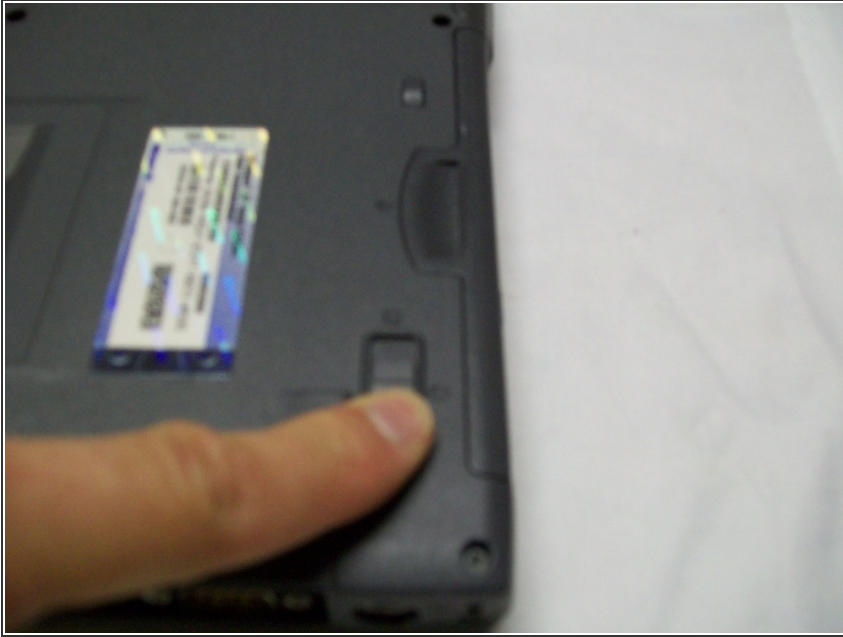
Step 3

- Slide button in the direction of unlock and hold.

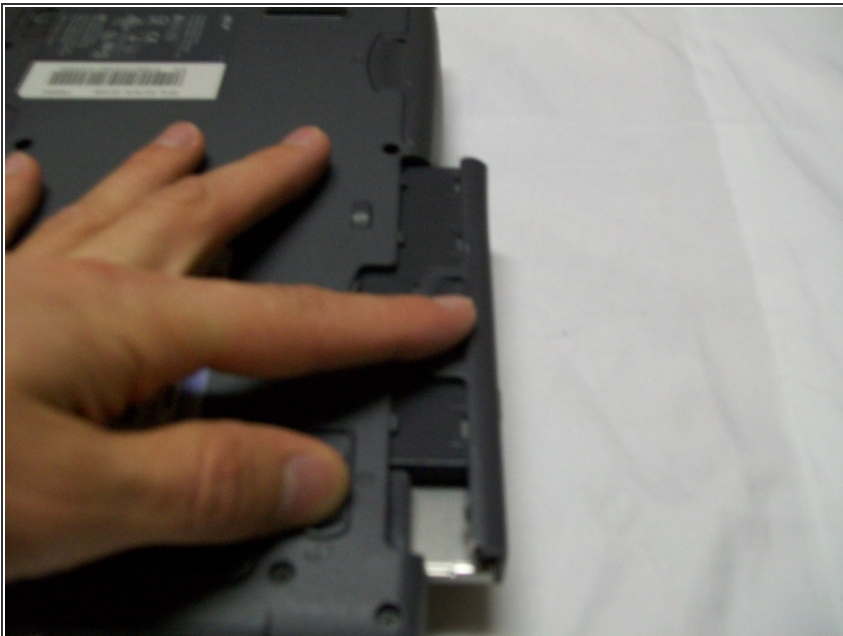
Step 4

- Gently pull the disk drive out.

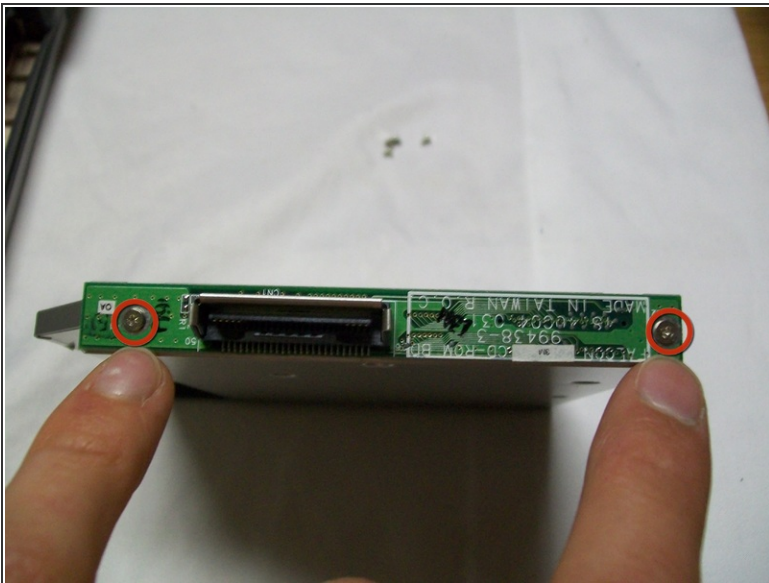
Step 8

- Remove the 2 screws securing the green chip.
